# melett

## 4 LACK OF LUBRICATION /OIL STARVATION

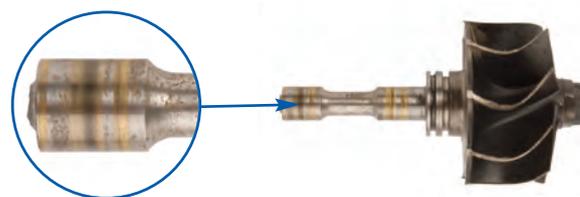
Material transfer from journal bearing

- Oil supply to the turbo is critical, always check oil pressures are correct
- Always remember to prime the replacement turbocharger with oil before fitting.
- Avoid using silicone on oil gaskets as they can easily become detached and block oil passages
- Clean or replace oil inlet pipes to remove carbon deposits or sludge that could restrict oil flow to the bearing systems
- Use fresh oil and new oil filters (which have been recommended by the engine manufacturer) when fitting a replacement turbocharger

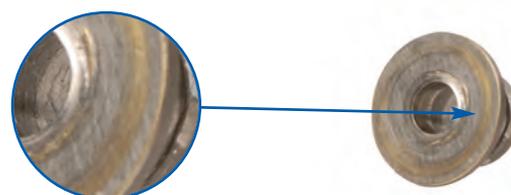
Material transfer from thrust bearing

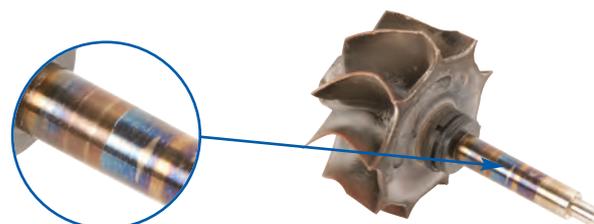
Discolouration to diameter of shaft and wheel

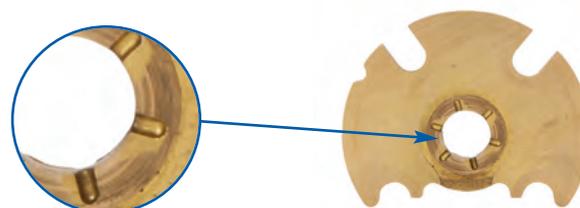
Excessive wear to thrust bearing

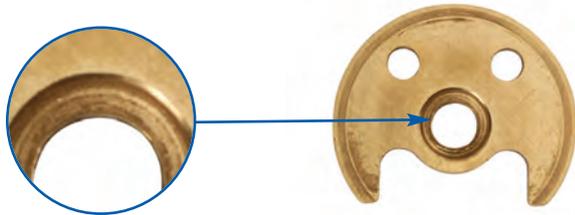
Excessive wear to thrust bearing

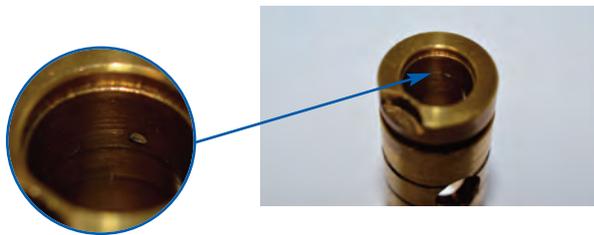
Excessive wear to journal bearing
